STRUCTURAL MATERIALS DIVISION

STRESS-CORROSION CRACKING  
OF HIGH-STRENGTH ALLOYS

Report No. 0414-01-9 (Quarterly)

May 1963

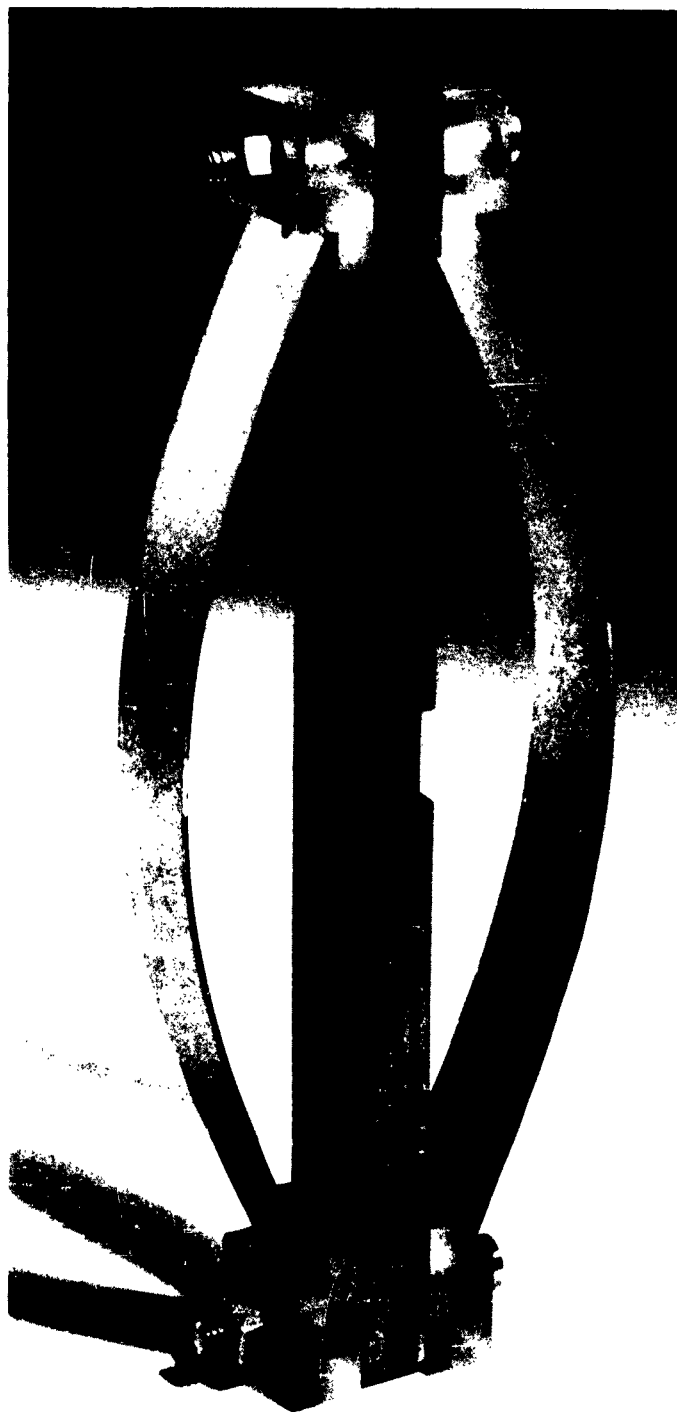
Insulated Phelps Bent-Beam Specimens

The bent-beam test is the primary method used in this program. A total of 595 tests of this type are being conducted. Figure 1 shows an insulated bent-beam fixture with test samples mounted. Polycarbonate blocks 7.000  $\pm$  0.002 in. apart, attached to a stainless-steel holder, support the test specimen and insulate it from the holder. Specimens are machined to exact lengths to produce a maximum calculated outer-fiber stress that amounts to 75% of the mean 0.2%-offset yield strength.

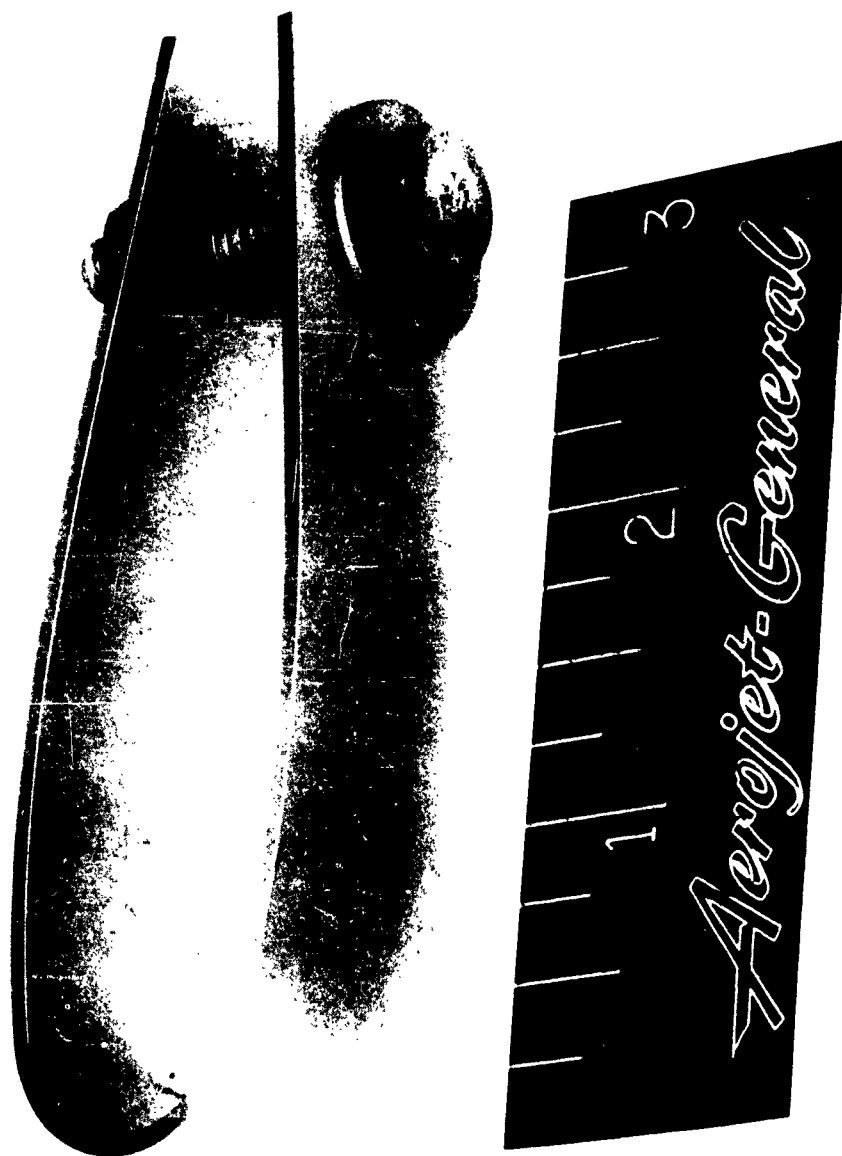
U-Bend Test Specimen

Figure 2 shows a U-bend test sample. This test was used extensively in the initial 2-year program to accelerate failure times by producing stresses beyond the yield strength of the material. The U-bend test method is now being used only for the 6Al-4V titanium alloy because initial testing indicated that some of the maraging steels would not withstand the drastic distortion of a U-bend while in the fully aged condition. Although it is possible to give the samples a partial bend in the annealed condition and to complete the U-bend after subsequent aging, it is believed that this procedure would not represent a realistic condition for study. The center-notch test described below is being used for acceleration of failure times.
